# New Technology for Highway Deck Plate Replacement

Hanshin Expressway has maintained 250-km long elevated highways in Osaka and Kobe Area, Japan for more than a half century. Consequently, 40% of entire network is older than 40 years under the heavy urban traffic. The introduction of a new technology to replace aging and damaged concrete bridge deck plates is a cutting-edge solution to realize longer-life expressway structures.

# Expressway Renewal Project

### Expressway Inspection & Diagnosis

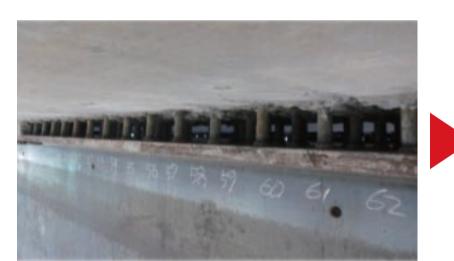
Apply WJ to remove the connecting concrete

For shortening road closure, some parts of rigid concrete are preliminary removed to expose connection studs between bridge girder and deck plate.

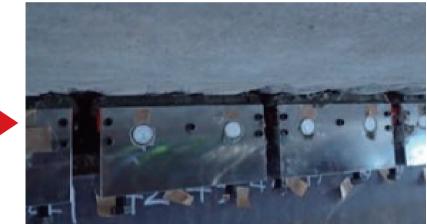
Install temporary reinforcement (flange guard) between the girder and the floor base

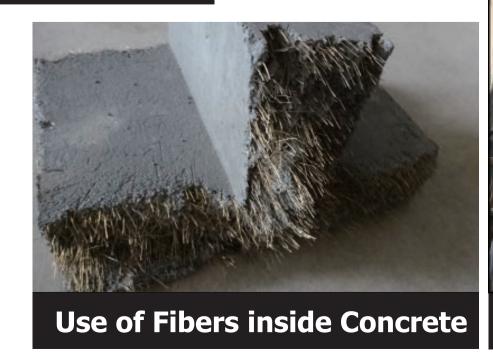
Newly developed lightweight and durable rigid concrete bridge deck plate called "Ultra-strong Fiber-reinforced Concrete (UFC)". deck plate is lighter and more durable than conventional pre-stressed concrete deck plate. UFC deck can be flexibly applied to existing deck replacement projects and, therefore, is highly useful for bridge rehabilitation project especially in urban area.

- High durability material and two-dimensional pre-stressing technology contributes weight reduction for two-third, thickness reduction by 17%.
- Less preliminary treatment needed to the main girders

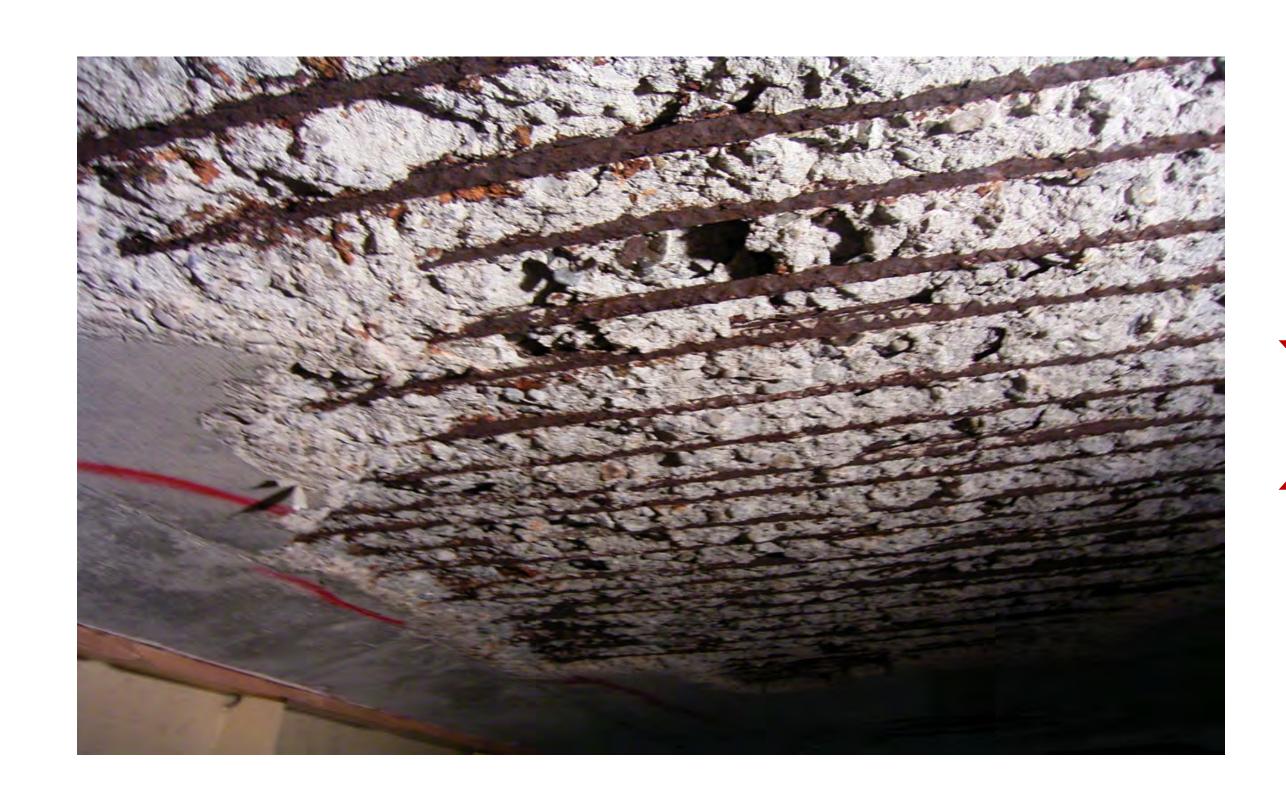
#### Severe deterioration on slab lower surface

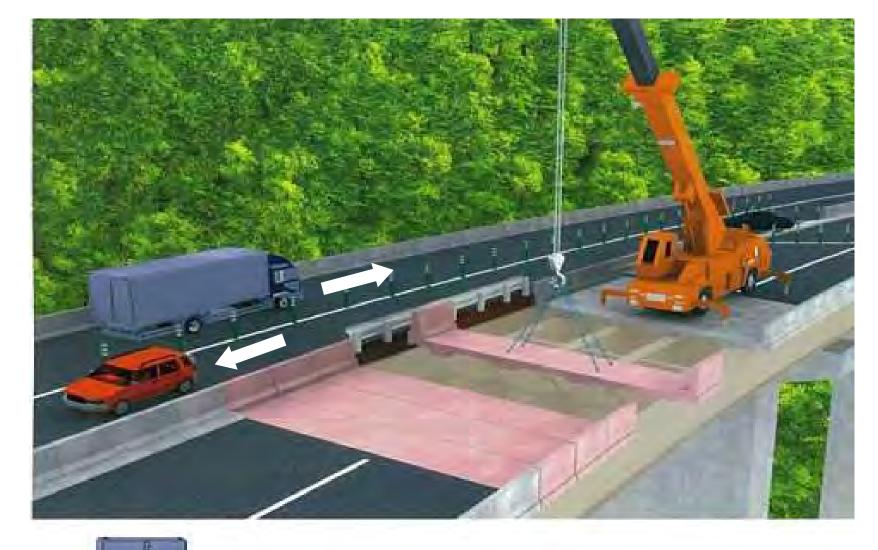
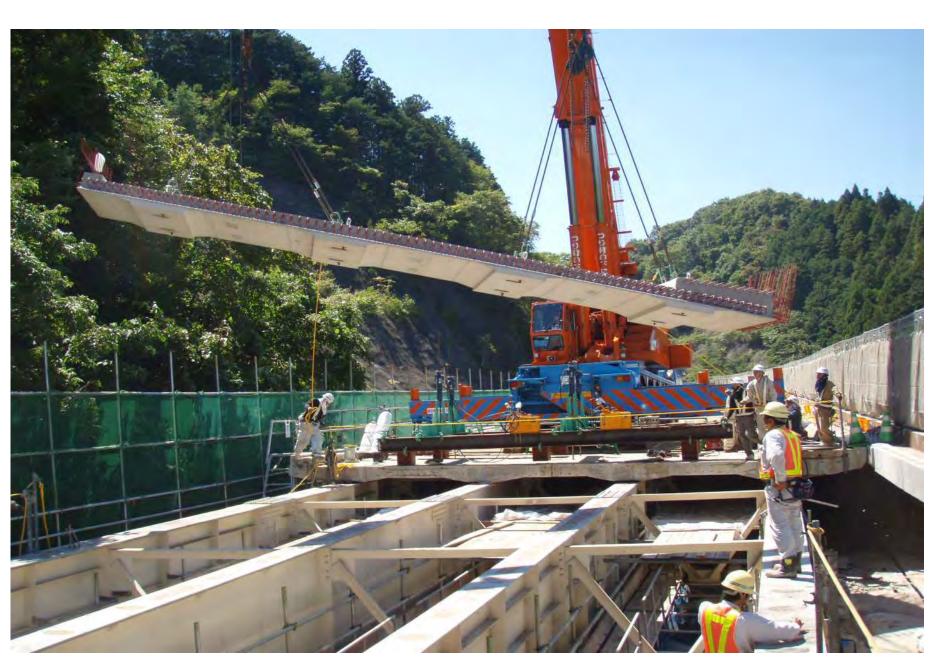
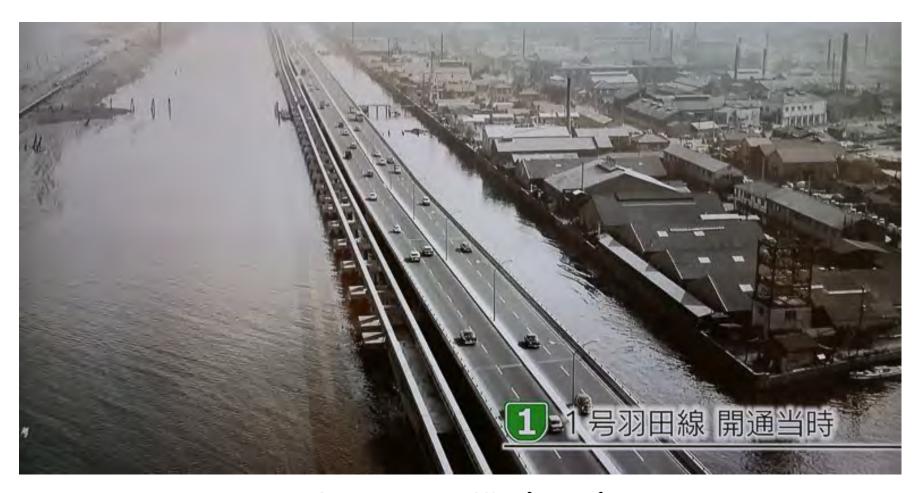
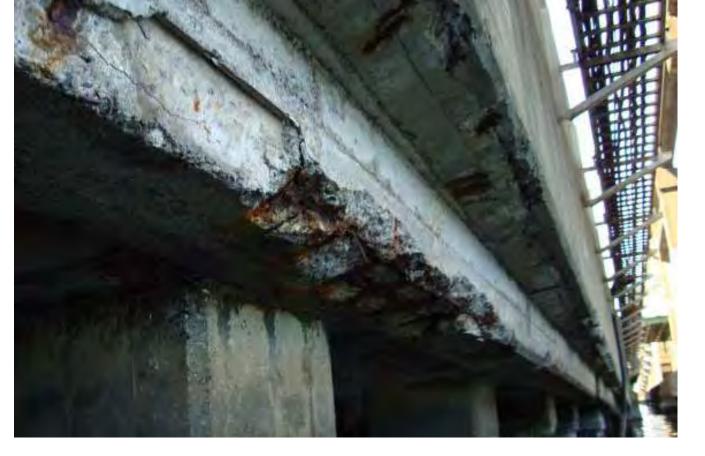
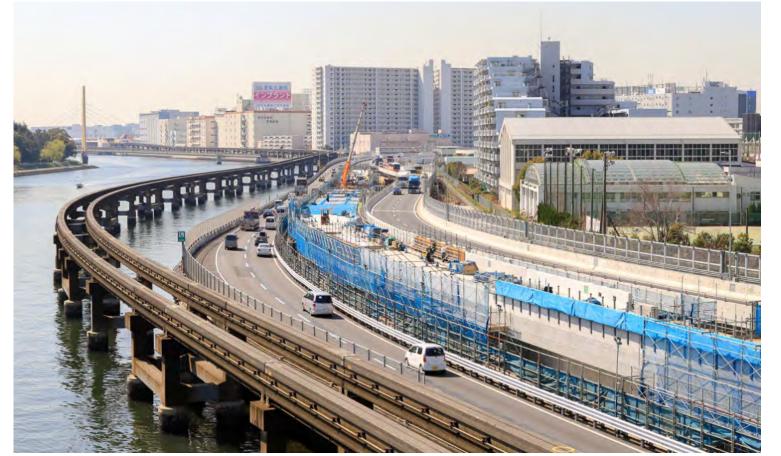
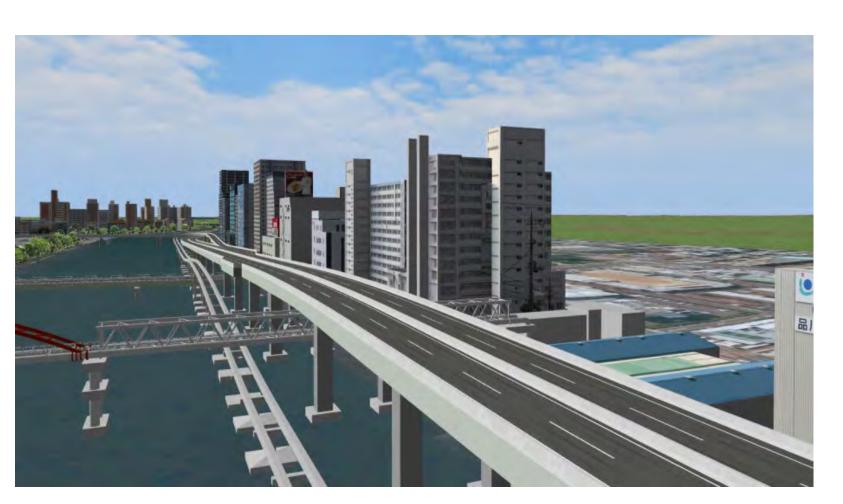
e.g. Replacement of RC concrete slab with PC precast slab

Open to Traffic (1963)

**Deteriorated Structure (2014)**

**Undergoing Renewal Works (2019)**

Renewed Segment (planed in 2026)

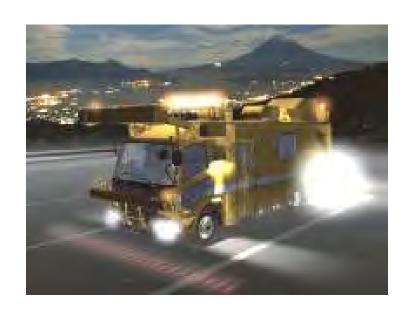
Crack analysis

(minimum 0.2mm

in width)

One of unique road surface inspection vhiecles, not only can measure rutting, cracking, and flatness ( $\sigma$ 10ft, IRI) but also longitudinal and transverse pavement measurements without making contact with the pavement.

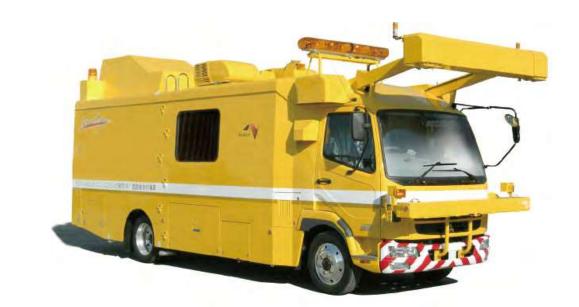
It can smoothly and safely perform all 6 functions at 100km/h without impacting the flow of other traffic.

**High-Speed Road Surface Measuring Vehicle (Road Tiger)**

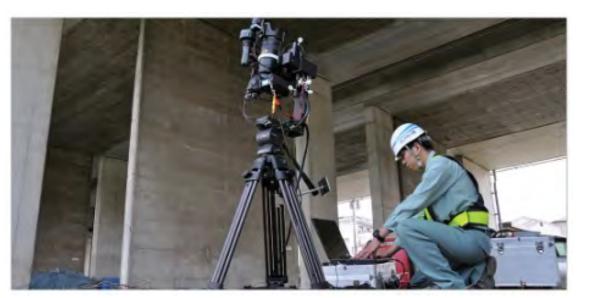
High definition images taken by digital camera or video camera makes it possible to inspect the surface of a structure in the same way as the close visual inspection. Through a computer analysis of the images, the clacks are automatically detected.

Bridge inspection using Digital Camera System

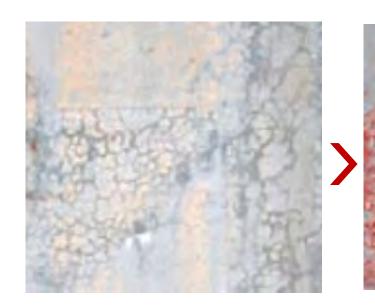
Automatic crack-analysis by computer

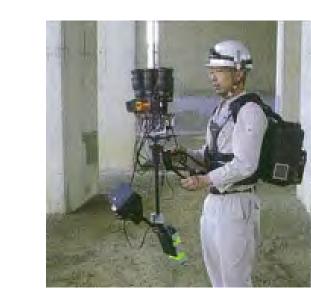
Video Camera System

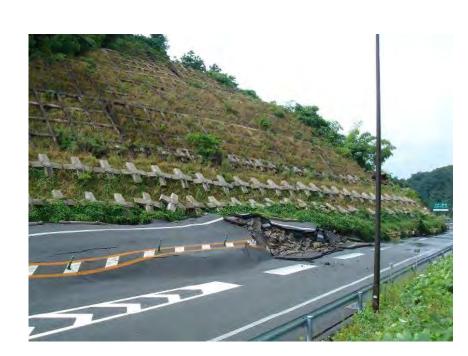
#### Ground anchor

New type of anchor installation filling up traditional anchor with inadequate anticorrosion function New type of anchor

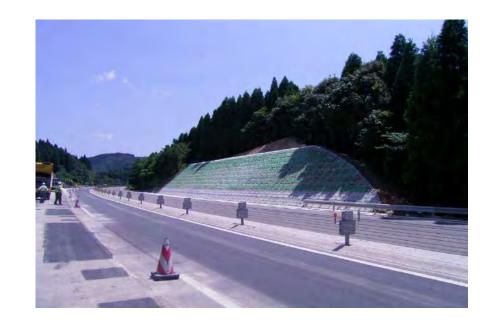
Measures against land slide

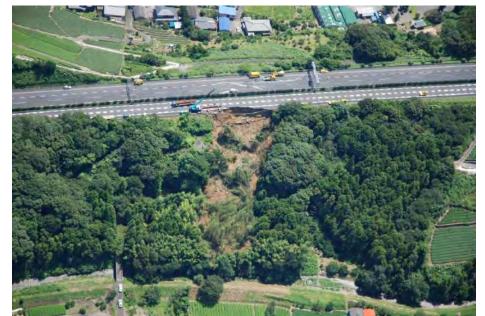
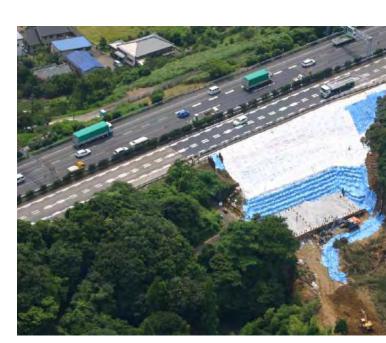
Immediately after the Surugawan earthquake, NEXCO-Central started emergency checkup and stopgap recovery, and 4 days later, finished temporary recovery for general traffic.

Aug. 11th 2009

Aug. 15th 2009 (4 days later)

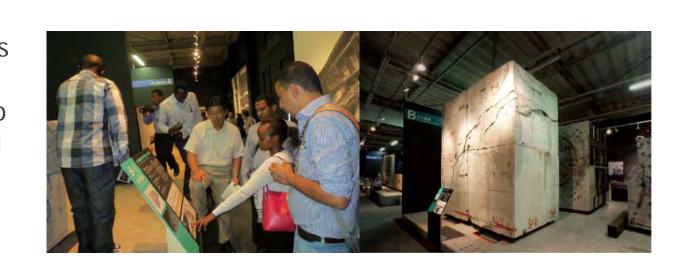
Great Hanshin-Awaji Earthquake occurred in January 1995, took precious lives and destroyed cherished livings of local communities. Earthquake Museum conveys how Hanshin Expressway responded in the 623 days to complete the restoration of the expressway system. It displays damaged structures and introduces new technologies and various activities which put into practice based on the lessons including disaster management support and educational assistance for disaster prevention.

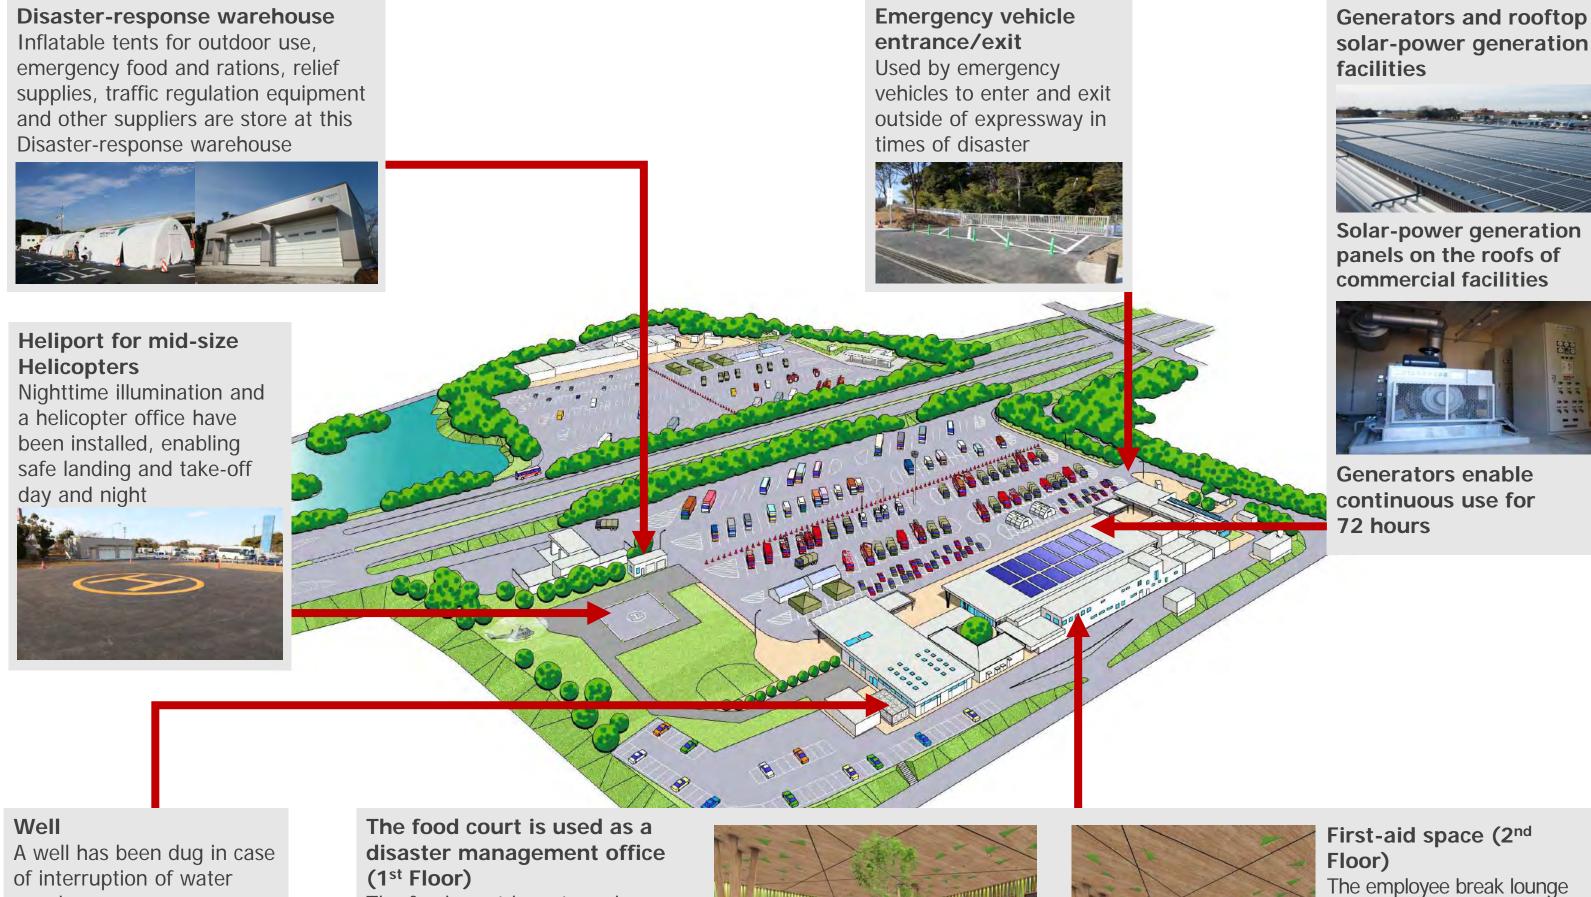
◆ Moriya Service Area (Southbound) on Joban Expressway, as a disaster management base

In the Great East Japan Earthquake, the Self-Defense Forces and firefighters heading to stricken areas used expressway rest areas as relay and support bases. Based on this experience and various issues, authorities are bolstering their disaster-response capabilities across Japan to respond effectively and efficiently to emergencies, using Moriya SA on the Joban Expressway as their model.
