*Nov 1<sup>st</sup> 2017*  
*International Symposium in Japan Road Conference*

# Pavement asset management practice in Norway

Even K. Sund  
Senior Principal Engineer

*Norwegian Public Roads Administration*  
*Directorate of Public Roads*  
*Roads Department*

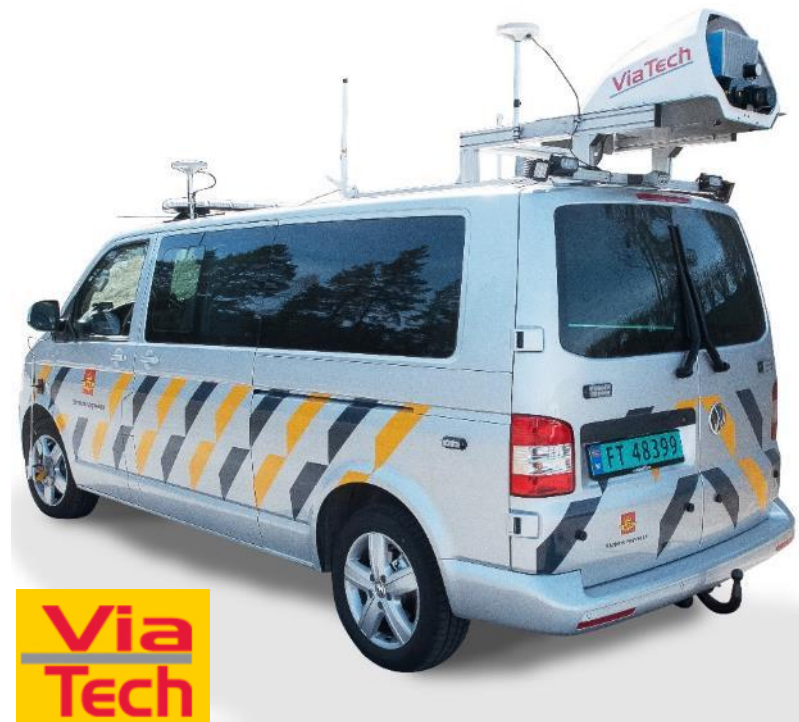
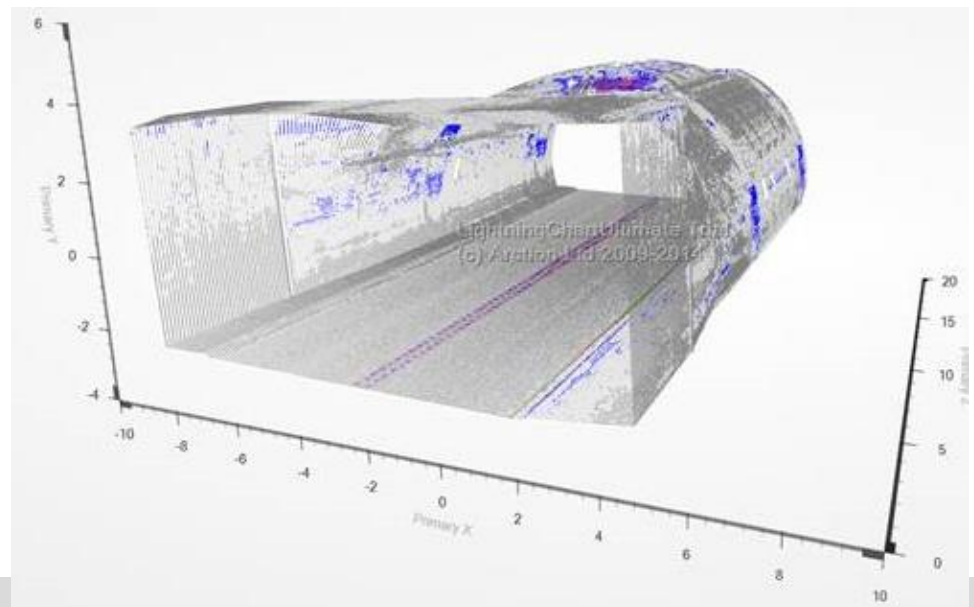
# Measuring rutting/roughness/crossfall and texture with ViaPPS:

- 360° scanning
- Double resolution compared to old eq.
- Better possibility for detection of damages (cracks, texture, homogeneity)
- Potential for new areas of use:

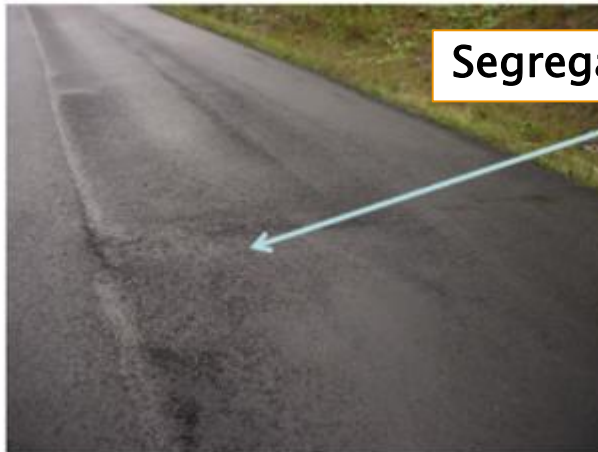
# R&D: Homogeneity- Measurement of texture/separation

Segregation

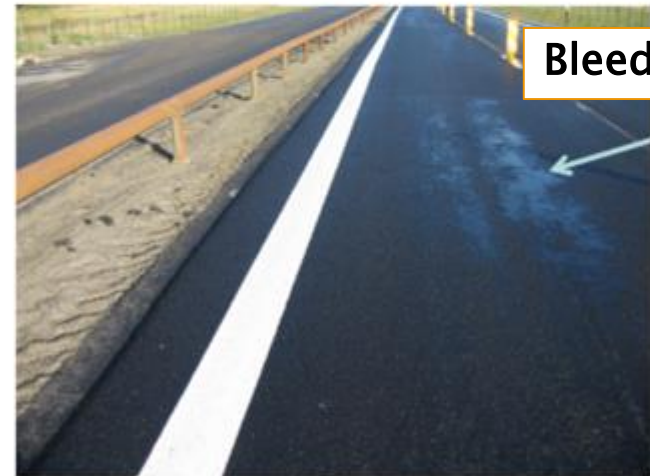
Bleeding

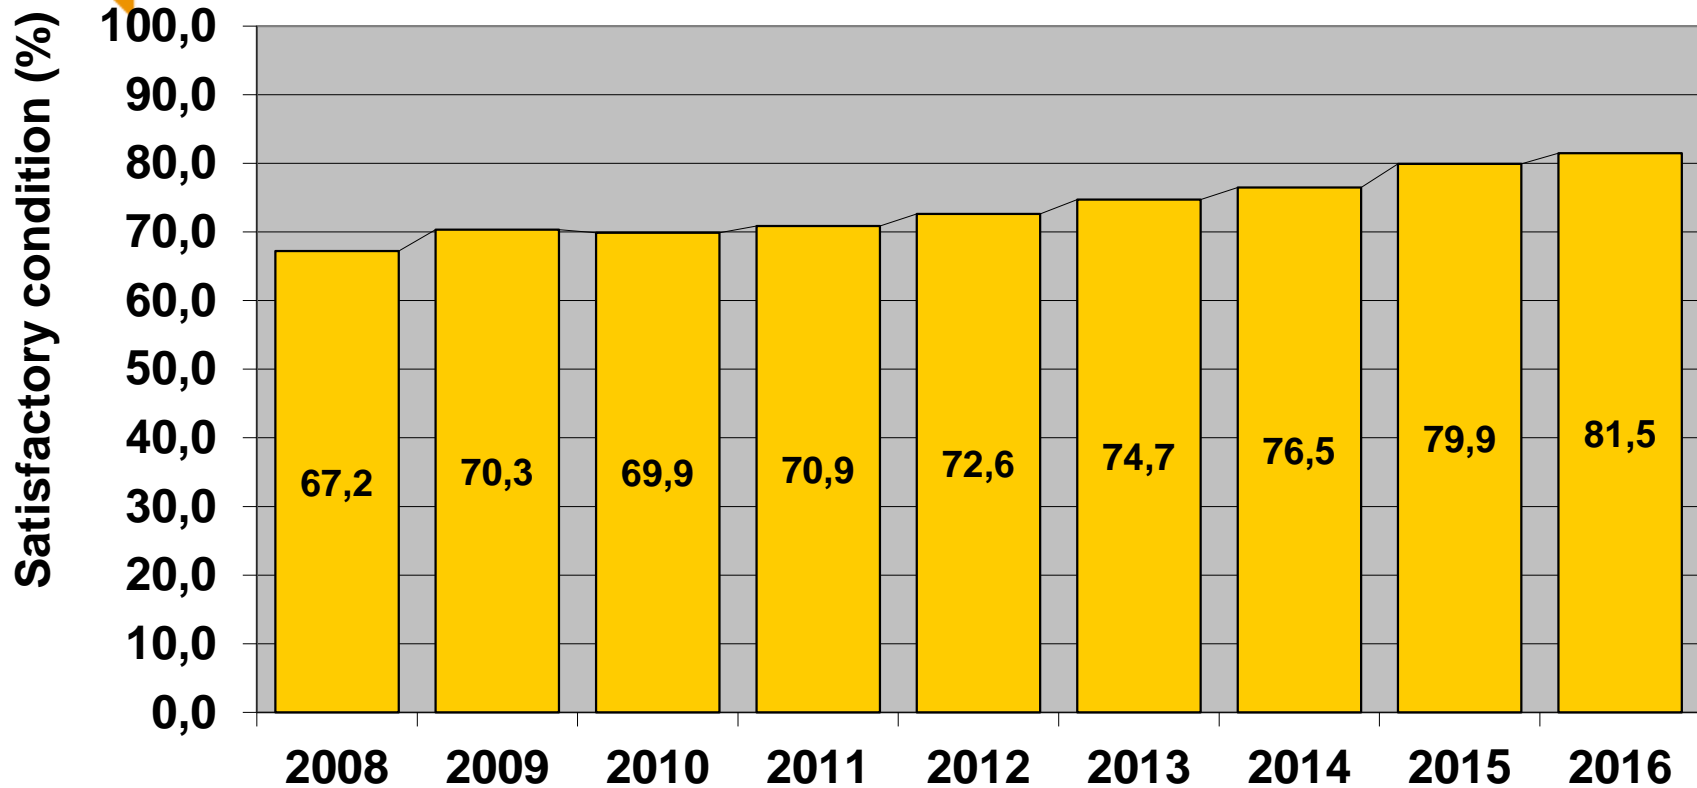
# Pavement condition development 2008-2016 (National roads)

Satisfactory: rutting < 18 mm IRI < 3,1 mm/m  
(20-meter median)

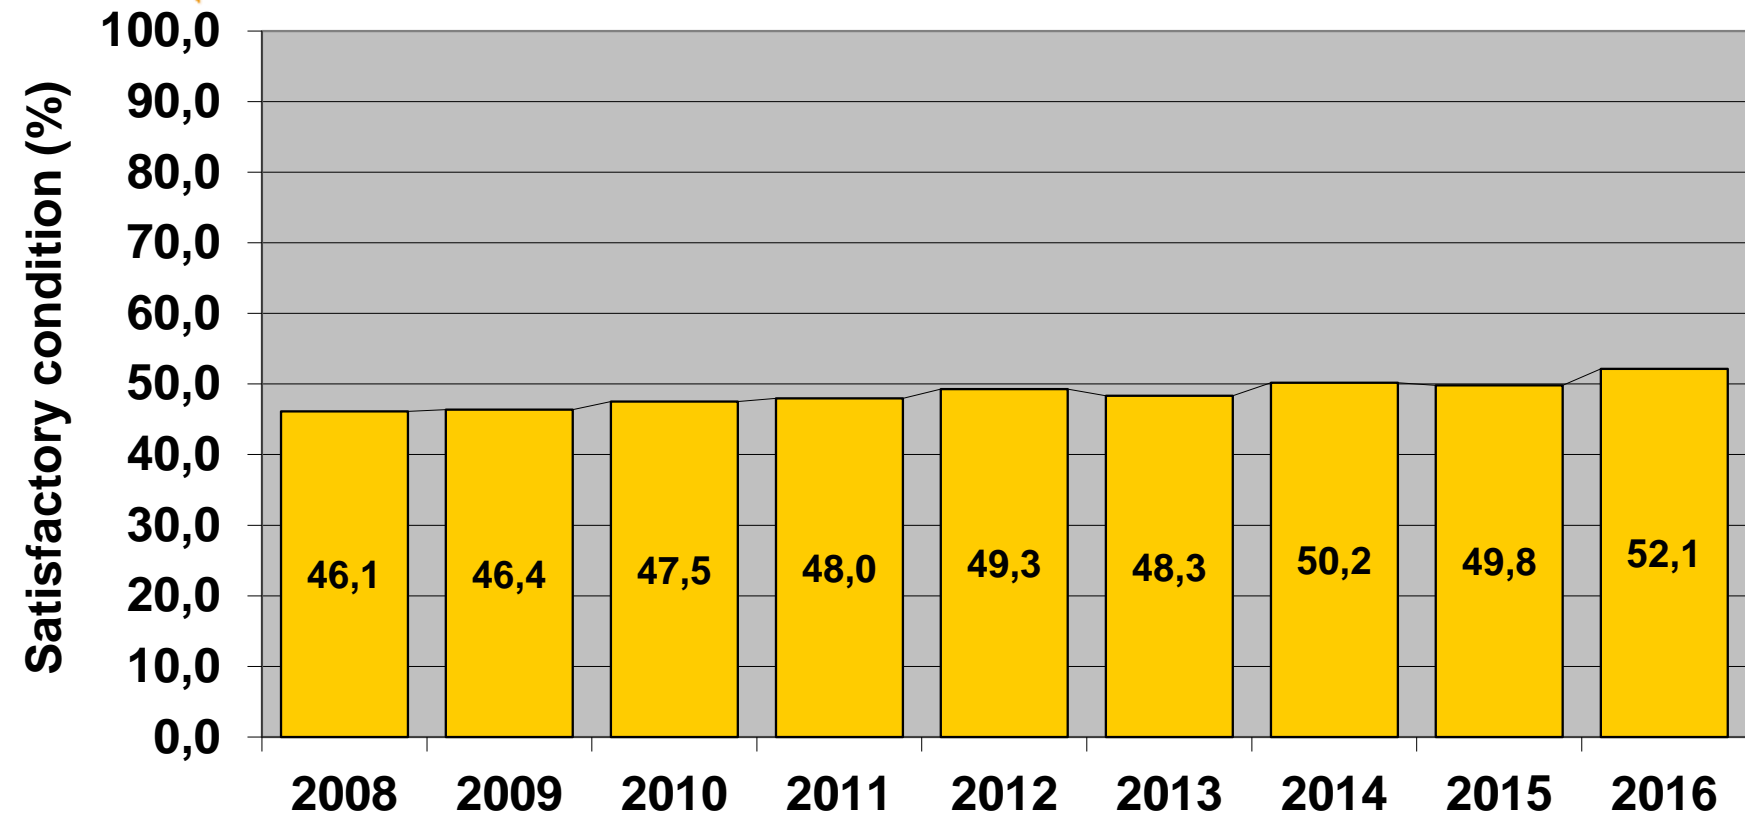
## Pavement condition development 2008-2016 (County roads)

Satisfactory: rutting < 18 mm IRI < 3,1 mm/m  
(20-meter median)

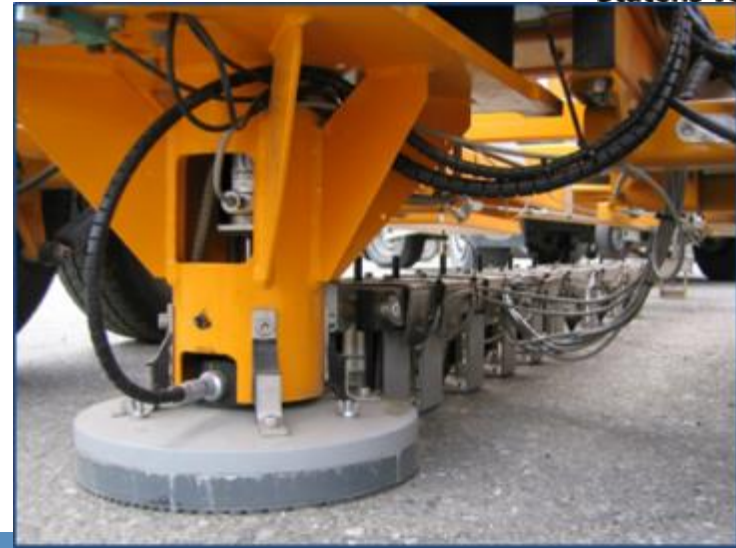
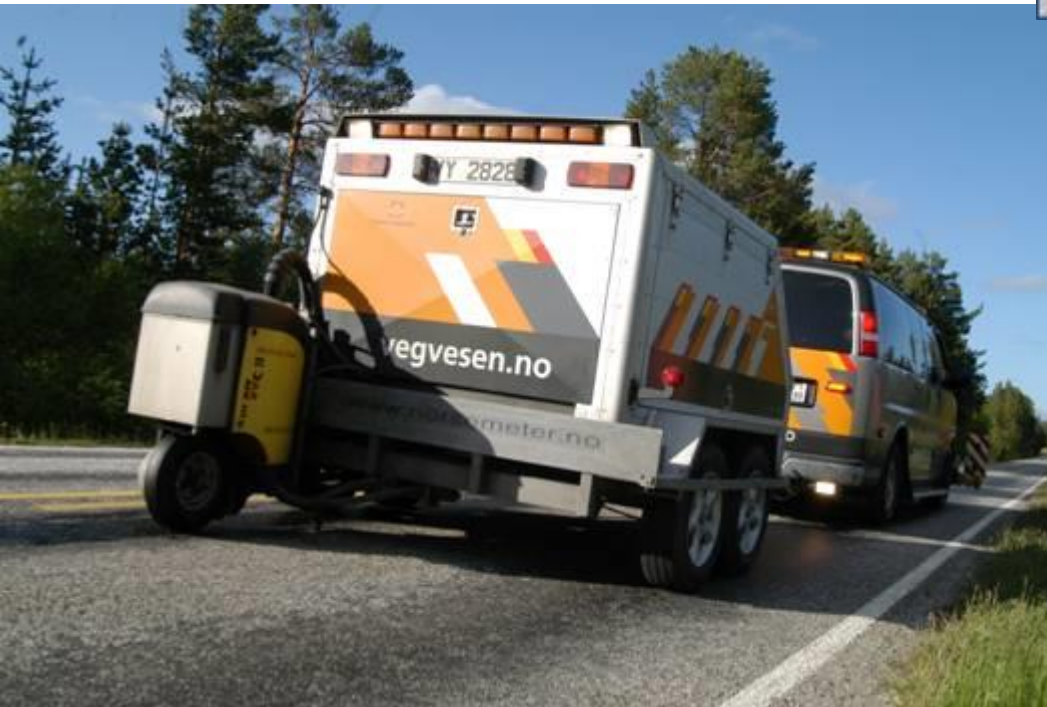
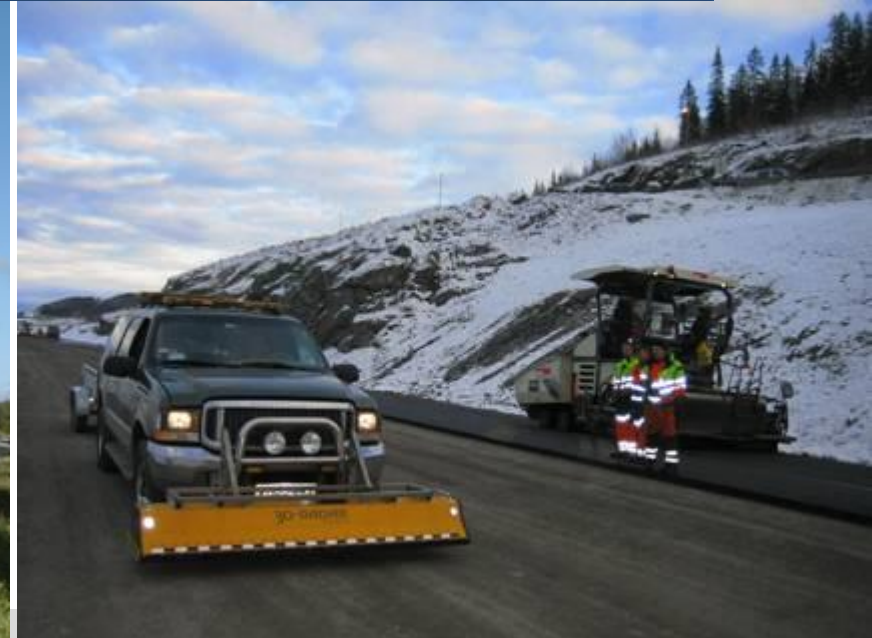
# Other measurements on pavements (not for whole road network)

- Falling weight deflectometer (FWD)
- Georadar
- Friction (summer)
- Core sampling
