# Durability checks

Following checks were introduced in 2002 in addition to earlier structural details.

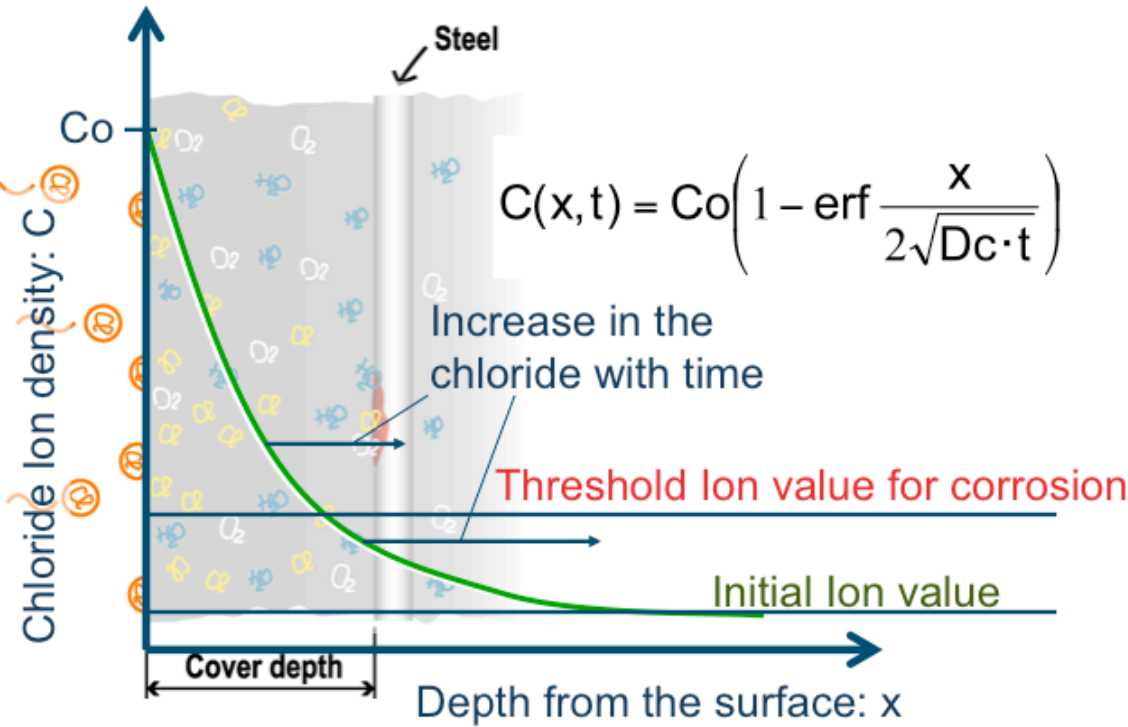
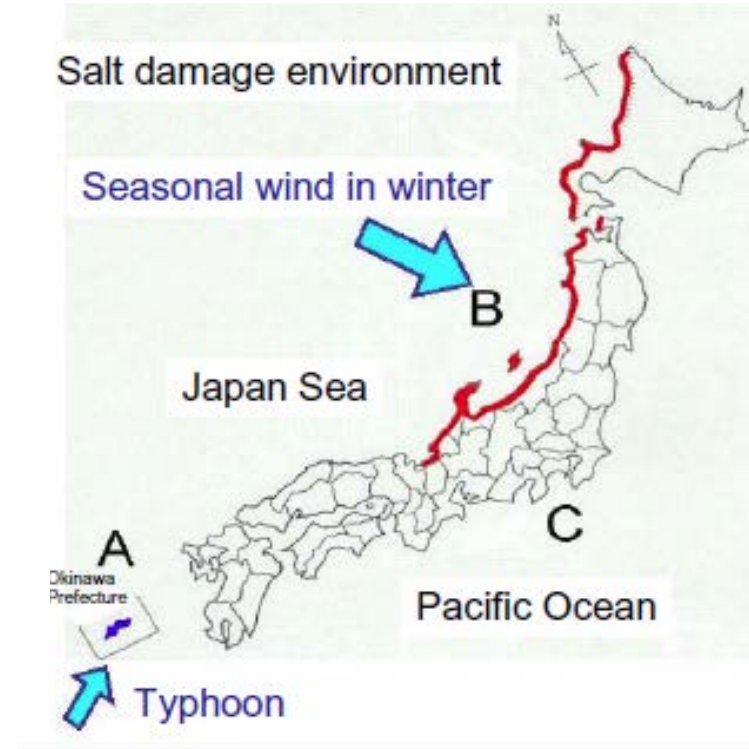
# Theory for the chloride ingress time-evolution and nation-wide observation of flying chloride reached to the surface of bridges

Minimum cover depths to prevent reinforcement from corrosion over 100 years for each regions

e.g Minimum cover concrete depths for cast-in-place prestressed concrete superstructures

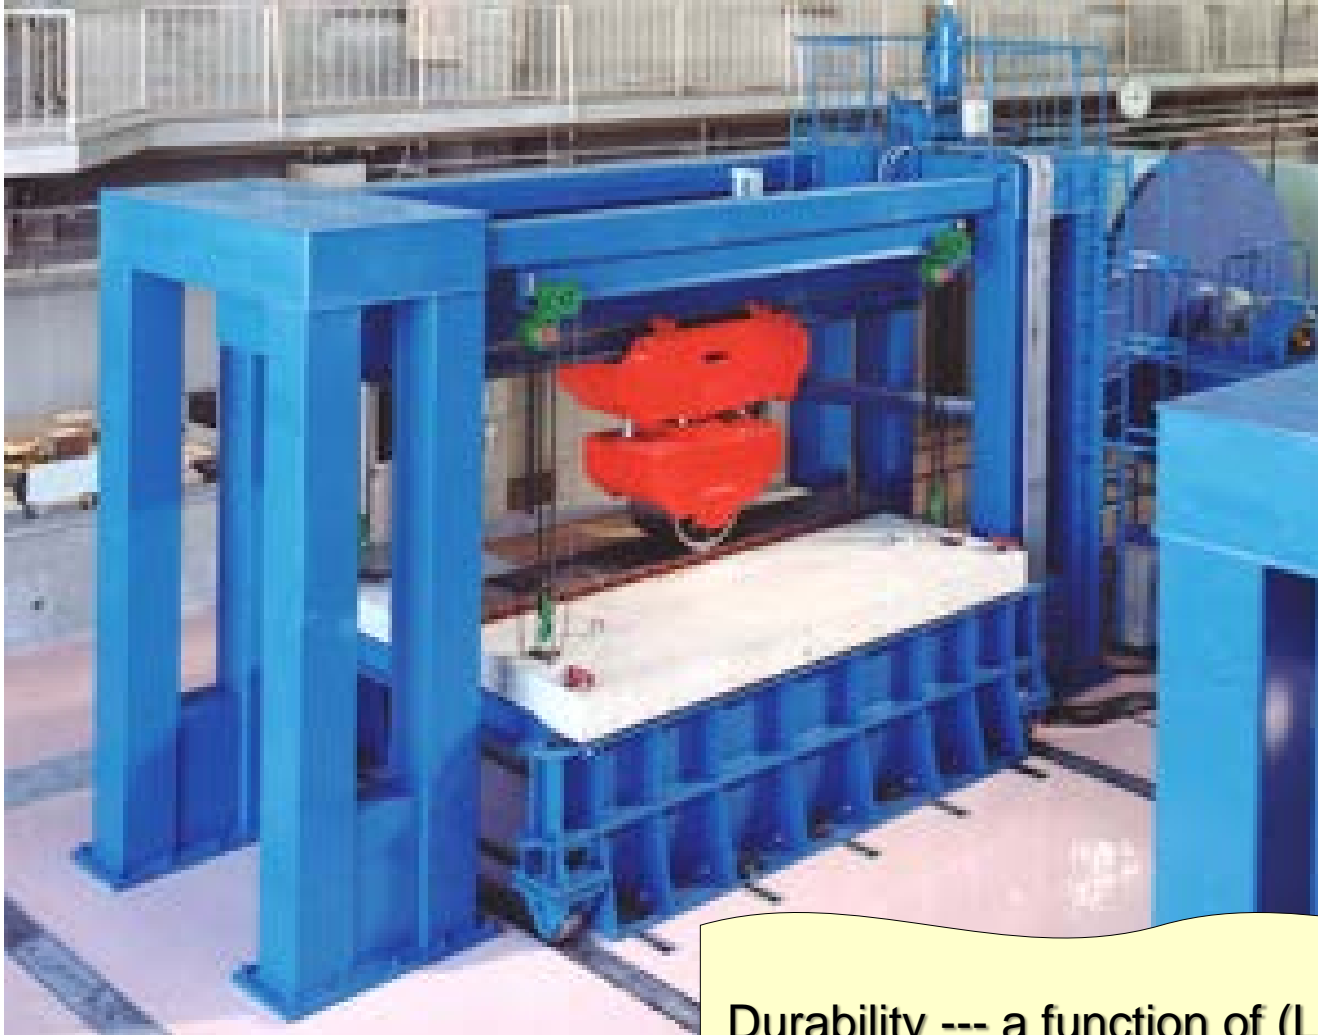
# Fatigue tests using a moving wheel loading machine

Durability --- a function of (Load)<sup>12</sup>

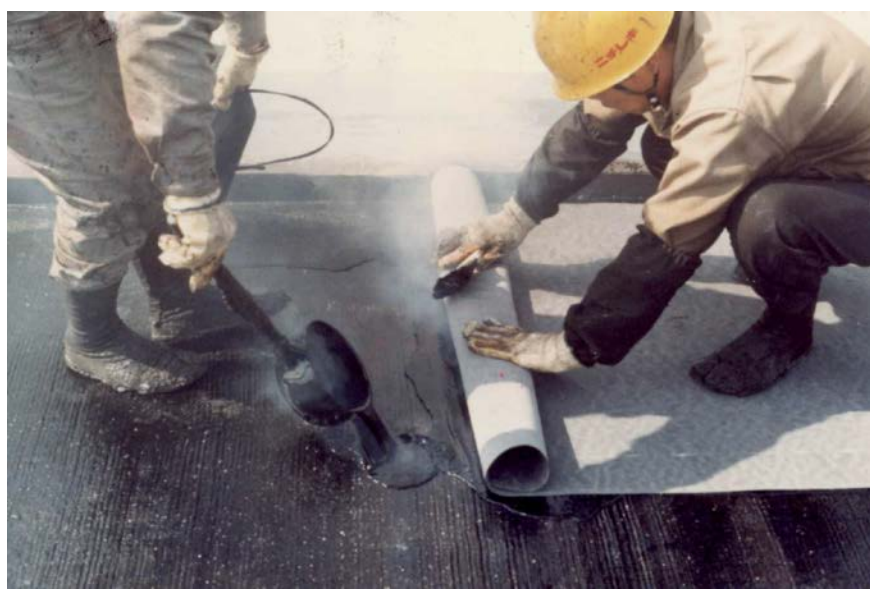
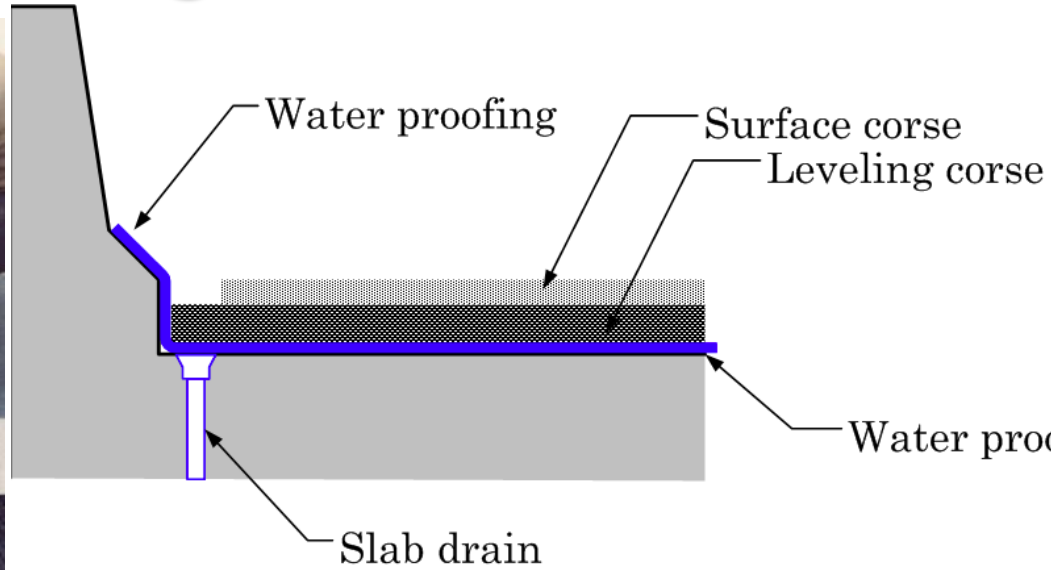
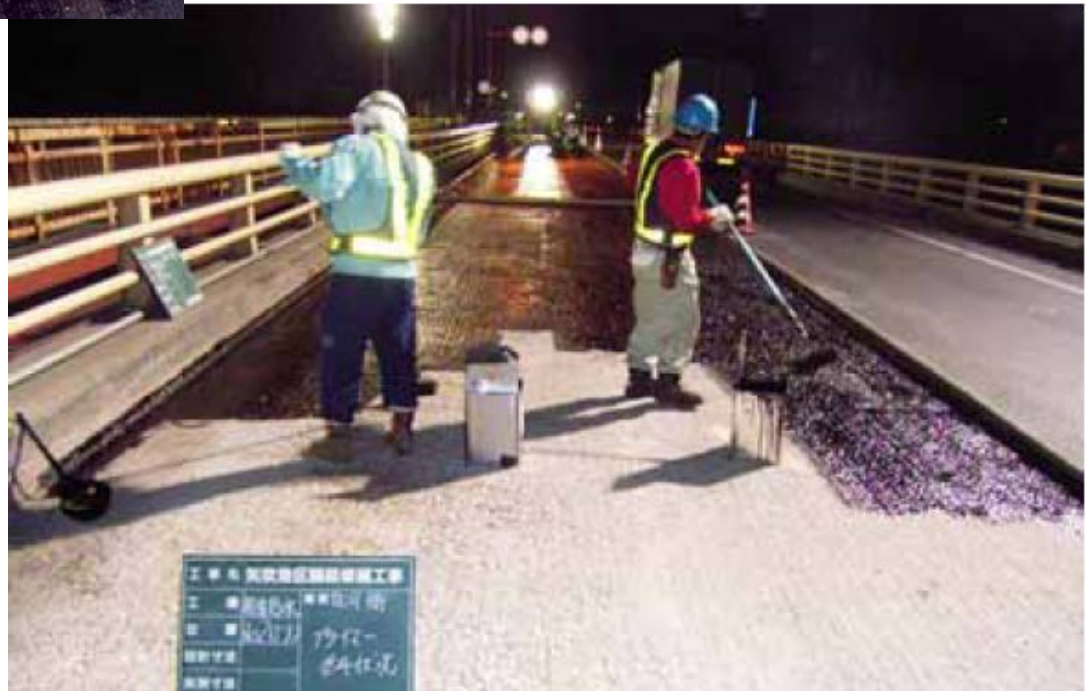
# Water proofing for decks

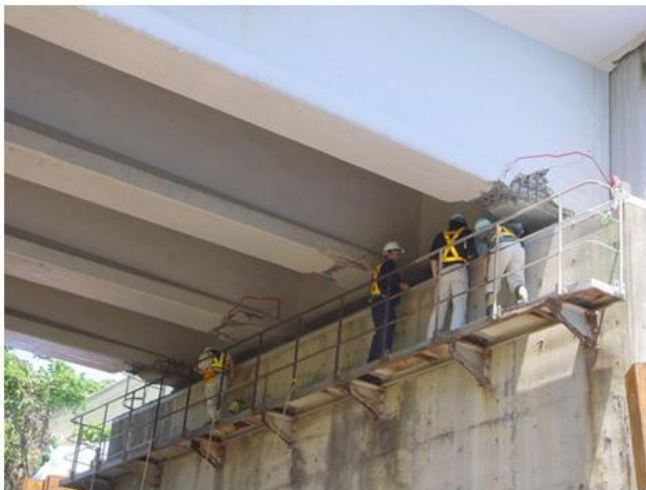
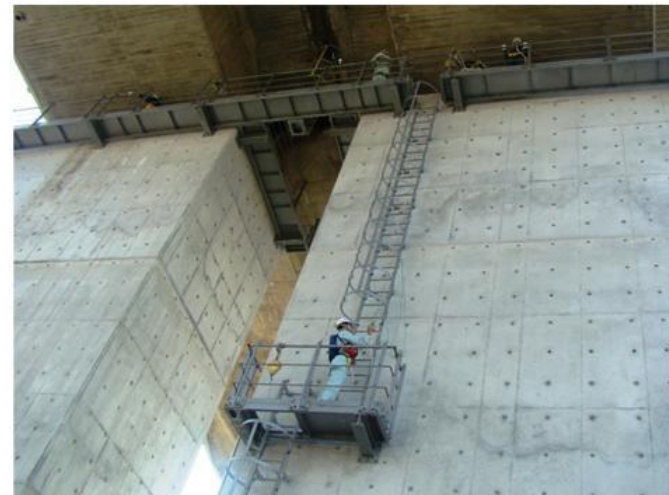
**Hole for inspection  
(No manhole on the other side)**

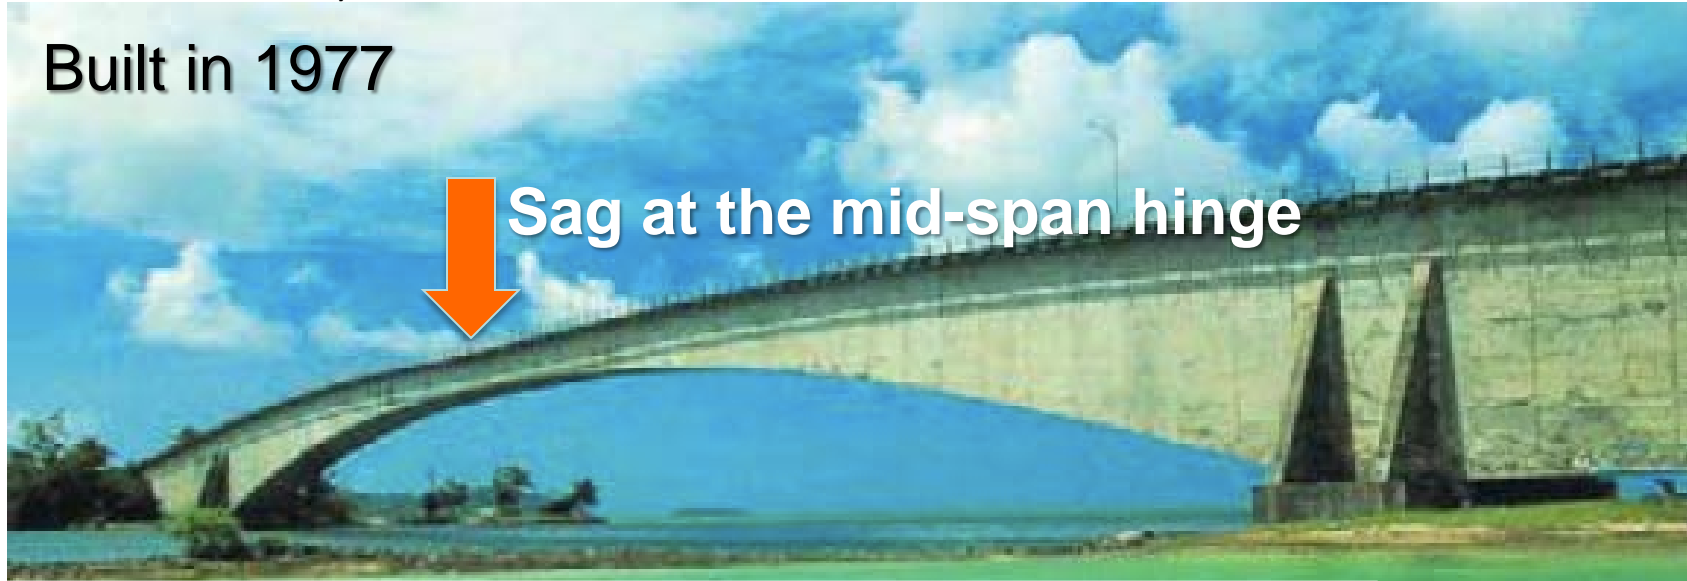
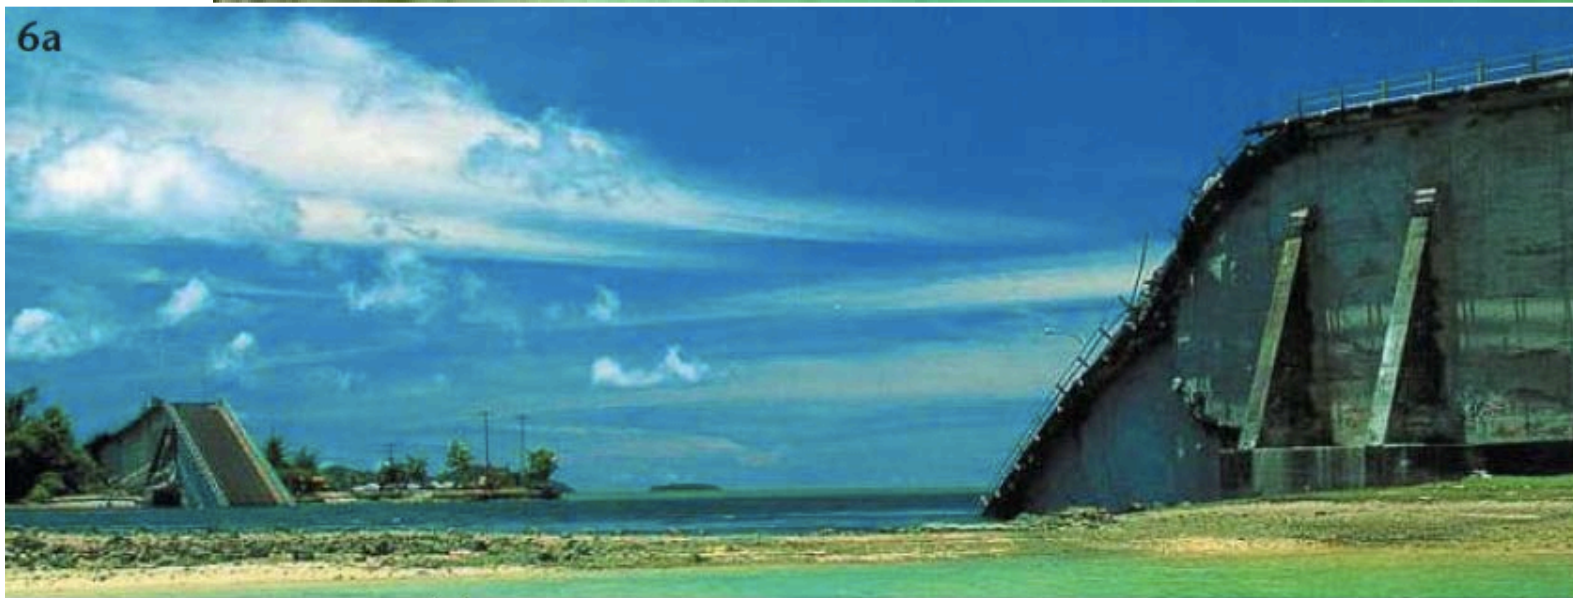
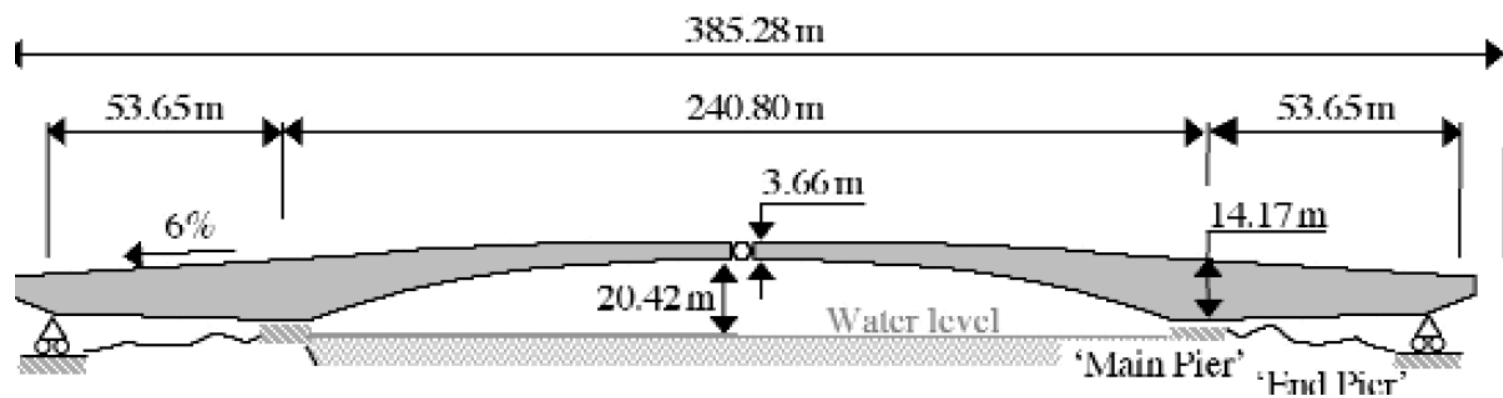
Collapse of Koror–Babelthuap, Palau, in 1996 (Burgoyne & Scantlebury, The Structural Engineer – 6 June 2006)

Built in 1977

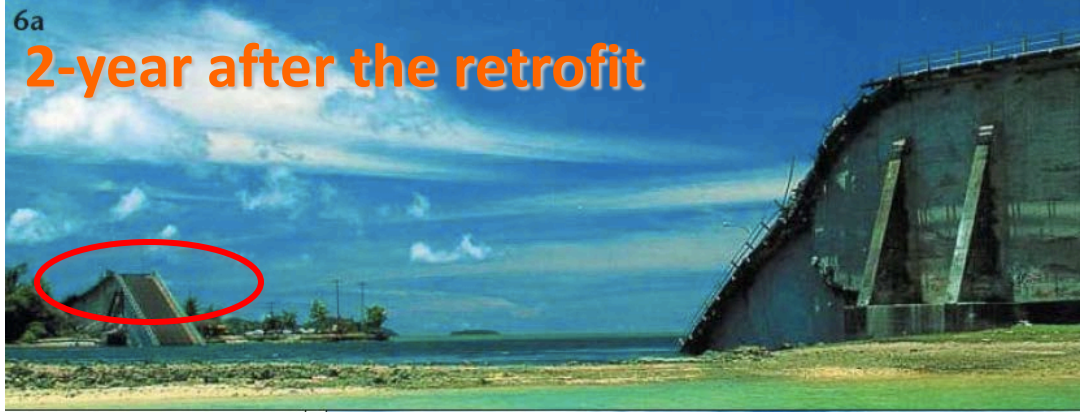
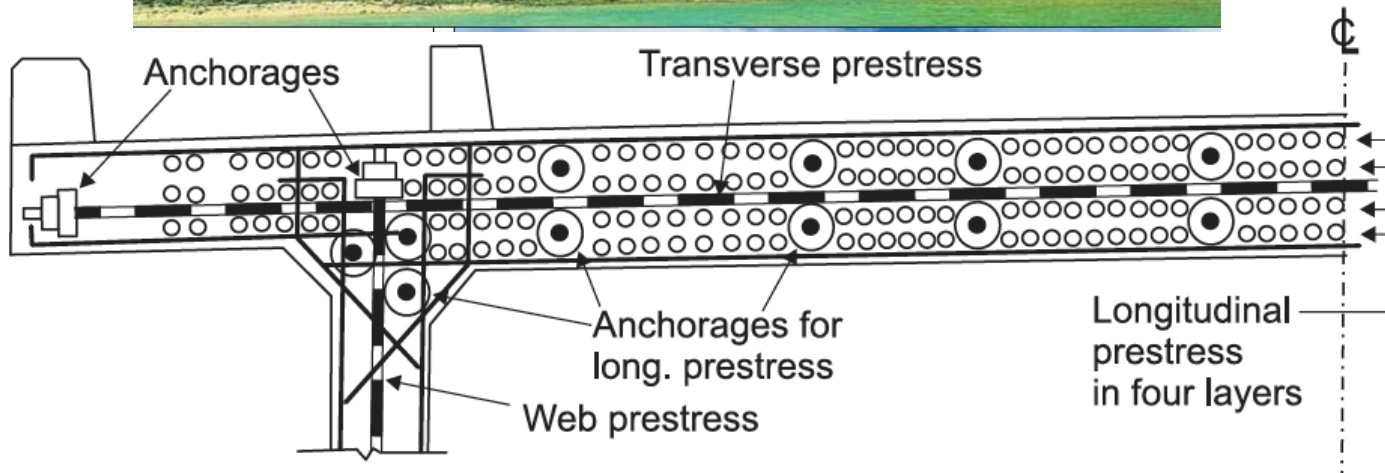
## 2-year after the retrofit

PC-cables were originally congested at the top flange

Little reinforcement surrounding PC cable anchorages

Concrete quality was not good → Larger creep factors.

Concrete deck material was partially removed prior to resurfacing.

**→ Localized stress and crack could appear at the top flange.**

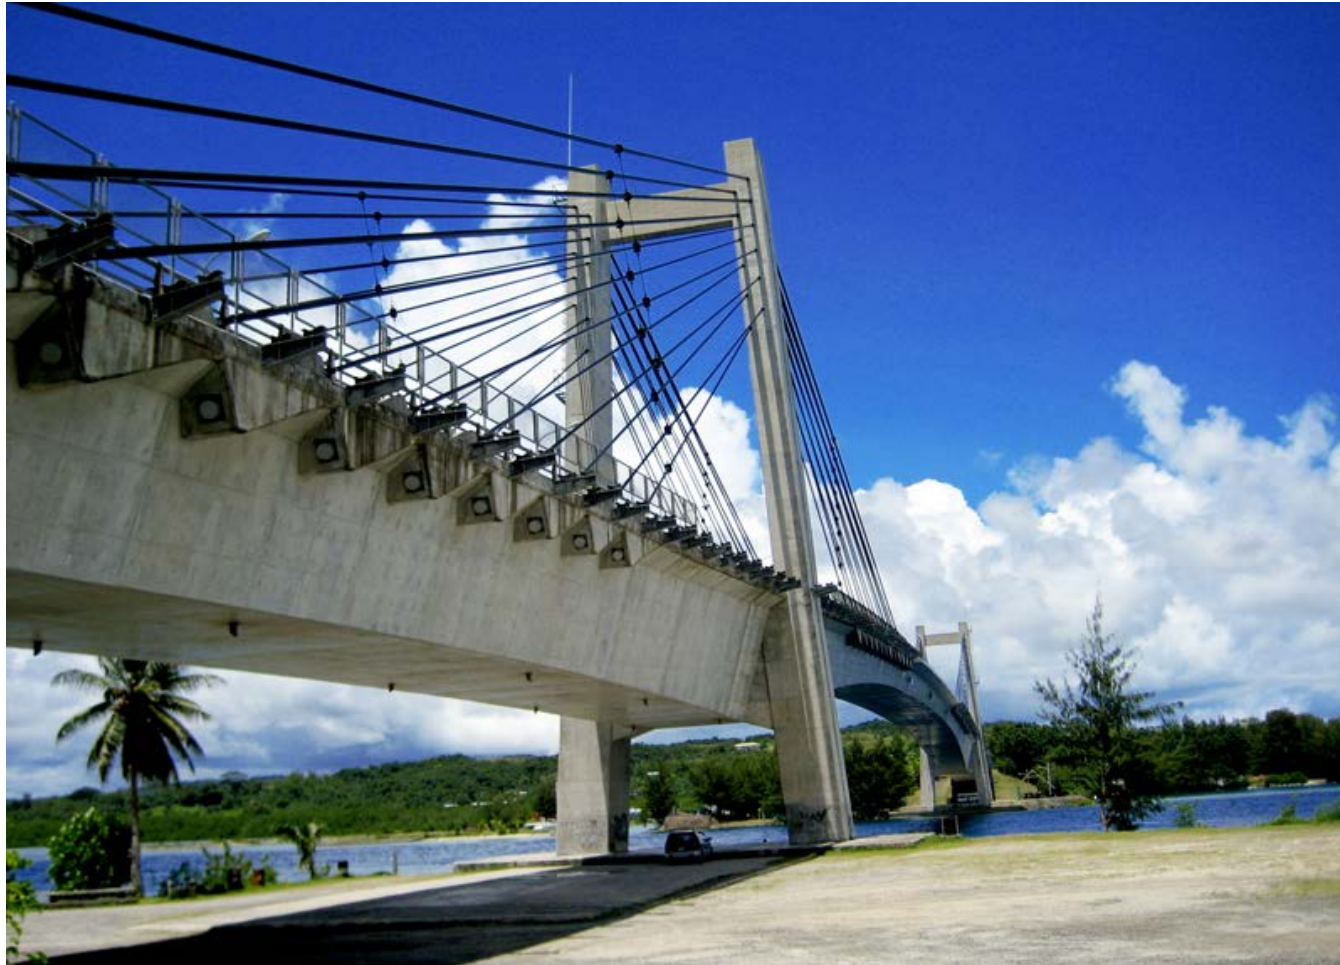
# Japan-Palau Friendship Bridge, 2002 (Aided by Japan)
